THE MALDEN SURVEY

A REPORT ON THE CHURCH PLANTS OF
A TYPICAL CITY, SHOWING THE USE
OF THE INTERCHURCH WORLD MOVE-
MENT SCORE CARD AND STANDARDS
FOR RATING CITY CHURCH PLANTS

WALTER SCOTT ATHEARN

Copyright 1920 by the
Interchurch World Movement
of North America

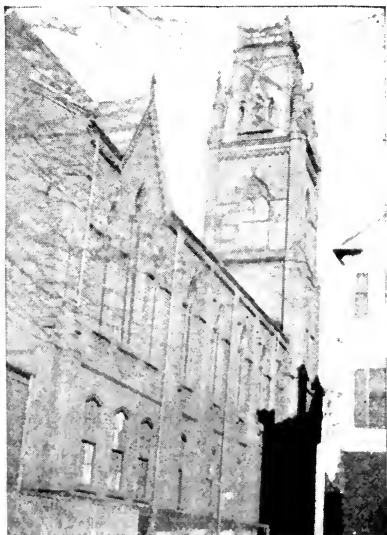
ILLUSTRATION 21. SIDE VIEW OF FIRST CONGREGATIONAL CHURCH SHOWING HOW ADJOINING BUILDING SHADOWS A CLASS ROOM

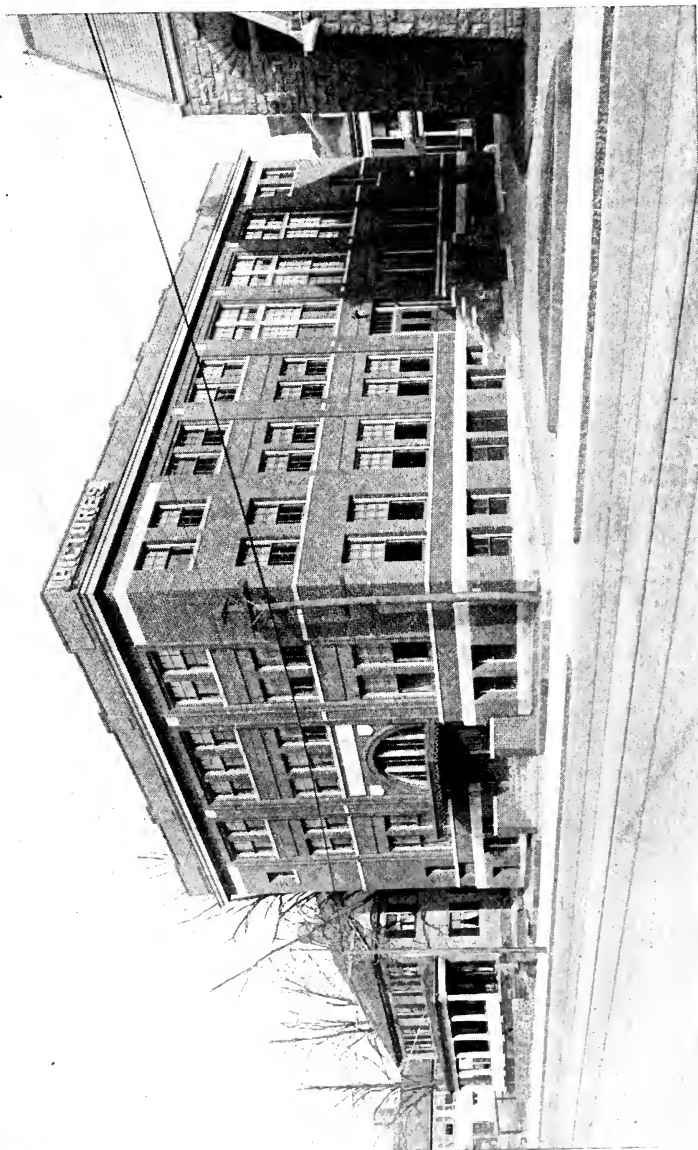
ILLUSTRATION 22. PARISH HOUSE, FIRST BAPTIST CHURCH, WHERE MALDEN PROVIDES ITS BEST PHYSICAL PLANT FOR RELIGIOUS EDUCATION. HOME OF COMMUNITY SCHOOL OF RELIGIOUS EDUCATION

Perhaps the most outstanding result of the effect of an inadequate site in a particular situation is that evident from study of illustration 22 and 20, pages 59 and 57. The religious school building of the First Baptist plant presents an attractive appearance from the church side. The site, however, is so small that it was considered necessary to build this structure with one side close to the neighboring property line. The building, on this side, has been given a blank wall, thereby detracting to a considerable degree from its beauty both within and without and from the advantages that accrue from good natural lighting of classrooms. A school building of this size requires a site sufficiently large for play and pageantry purposes.

face the weather. A covered way, conveniently entering both buildings, would meet this defect. See illustration 22, page 59.

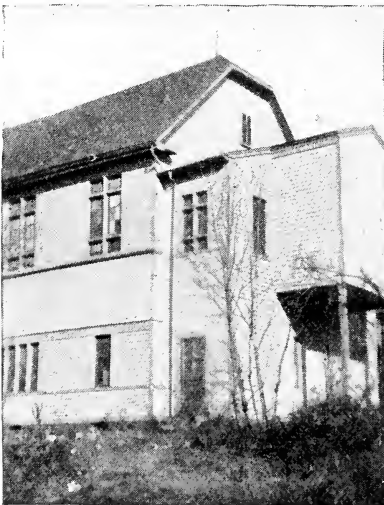
ILLUSTRATION 23. THE POORLY PLANNED MAPLEWOOD CONGREGATIONAL CHURCH ON ILL-KEPT GROUNDS

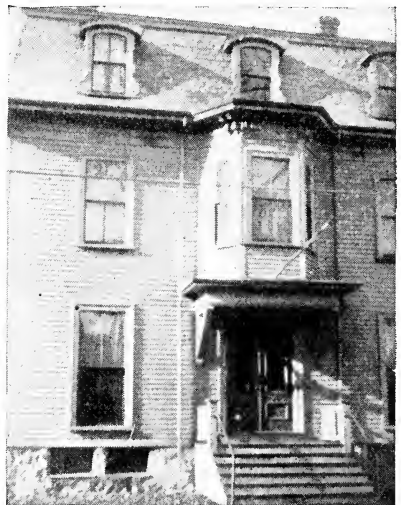
ILLUSTRATION 24. UNATTRACTIVE AND INADEQUATE TEMPORARY HOUSING FOR ST. PAUL'S SUNDAY SCHOOL ATTENDANTS

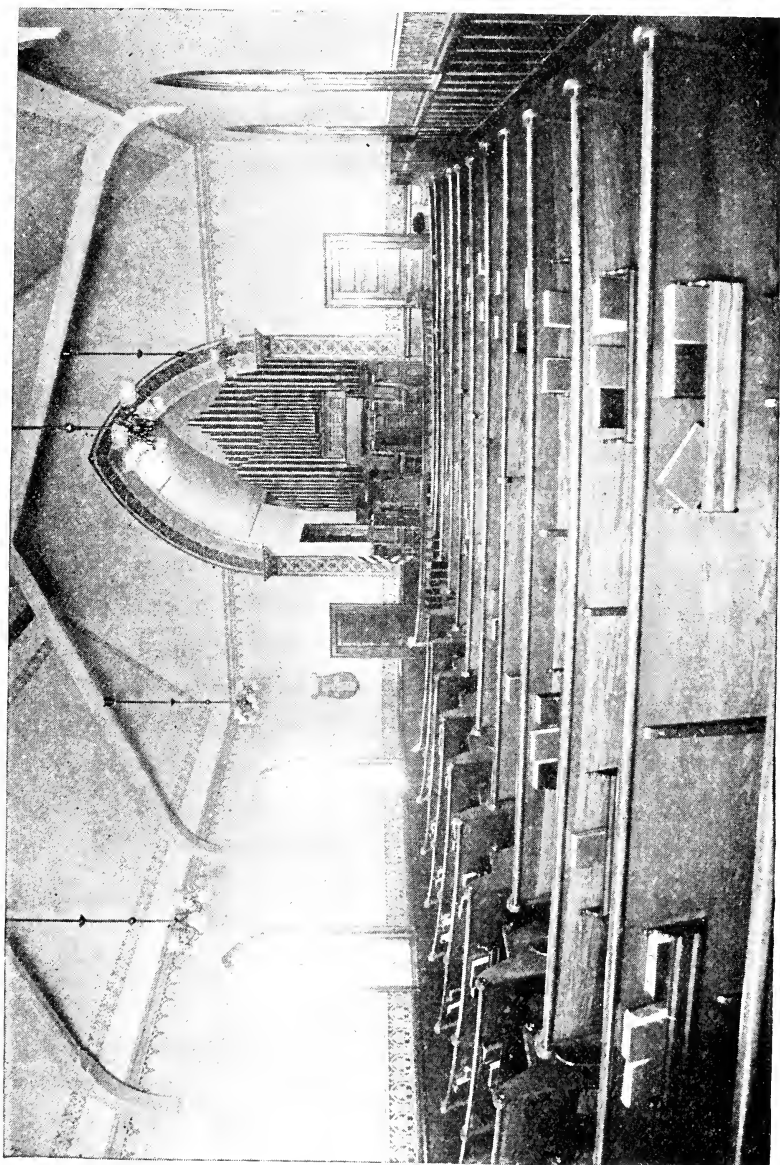
ILLUSTRATION 32. THE SECOND STORY AUDITORIUM, MAPLEWOOD METHODIST CHURCH, THE CHIEF EXIT FROM WHICH IS SHOWN IN ILLUSTRATION 34. A SECOND NARROW STAIRWAY, WHICH IS ALMOST UNUSABLE, IS AT THE RIGHT OF THE ORGAN

Illustration 34, page 71, reproduces the single main stairway which is used for exit from the auditorium of the Maplewood Methodist Church (see illustration 32, page 70). The secondary stairway to the rear of this auditorium is not superior to the type shown in illustration 36, page 74. This main stairway is of wood, lacks handrails has three turns and is inadequately provided with artificial light.

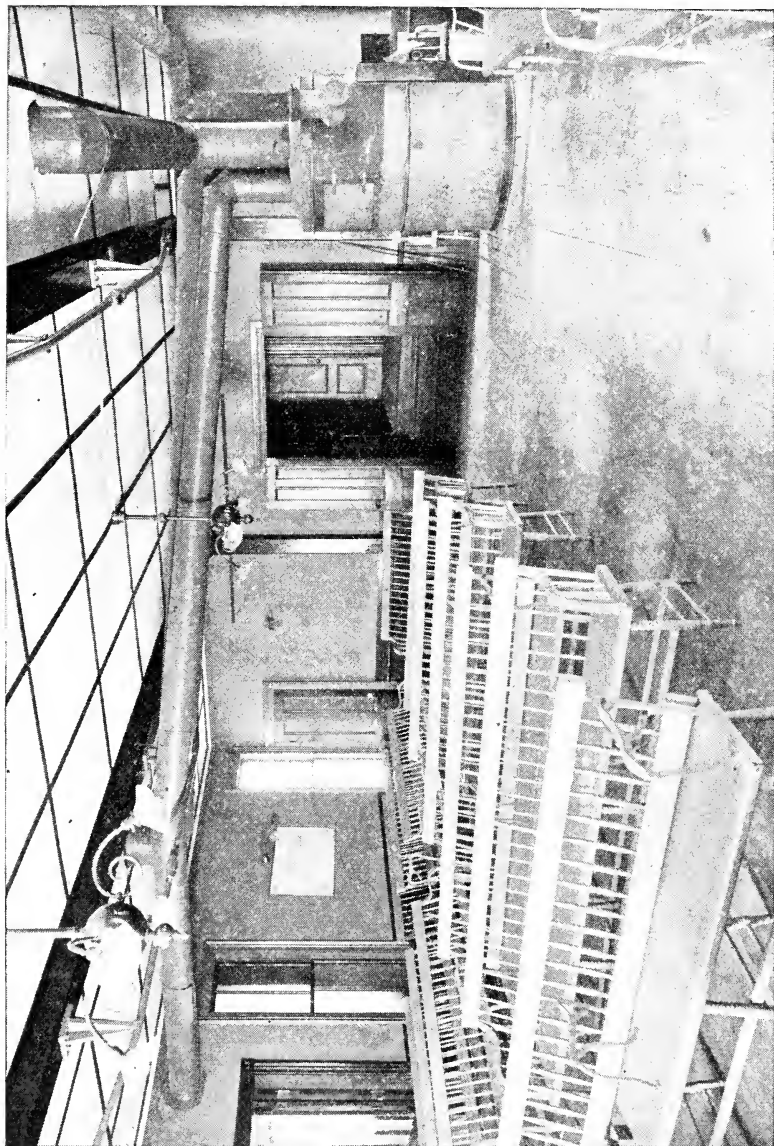
ILLUSTRATION 35. SHOWING THE IMPROPERLY PLANNED EXIT, THE UNSATISFACTORY SEATING ARRANGEMENTS, POOR LIGHTING AND INADEQUATE FURNISHINGS OF THE FIRST FLOOR SUNDAY SCHOOL ASSEMBLY ROOM OF THE LINDEN CONGREGATIONAL CHURCH

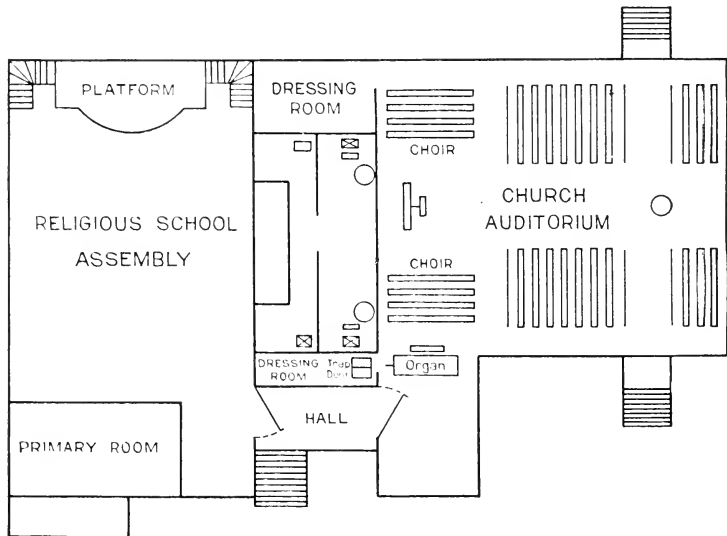
ILLUSTRATION 38. SHOWING INCONVENIENT ARRANGEMENT OF ROOMS AND DIFFICULTY OF PASSING AROUND ORGAN TO GET FROM SCHOOL ROOMS TO AUDITORIUM OF ST. LUKE'S EPISCOPAL CHURCH

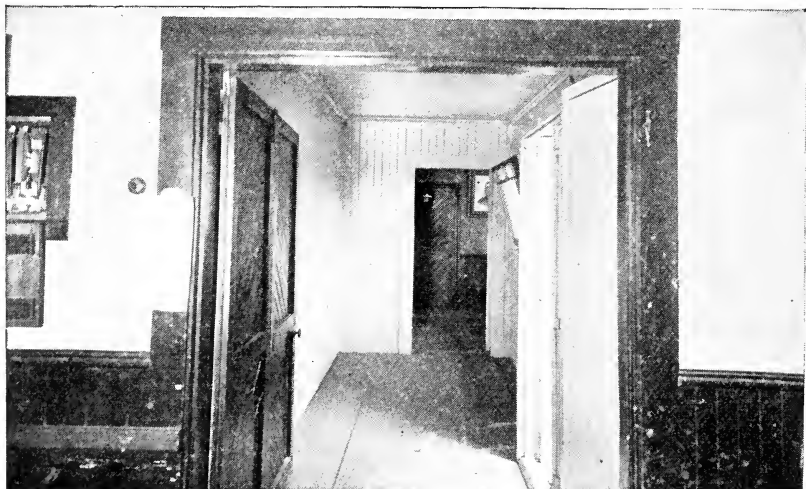
ILLUSTRATION 39. INADEQUATE FOYER AND CONNECTION BETWEEN RELIGIOUS EDUCATION ROOM AND AUDITORIUM IN ST. LUKE'S EPISCOPAL CHURCH

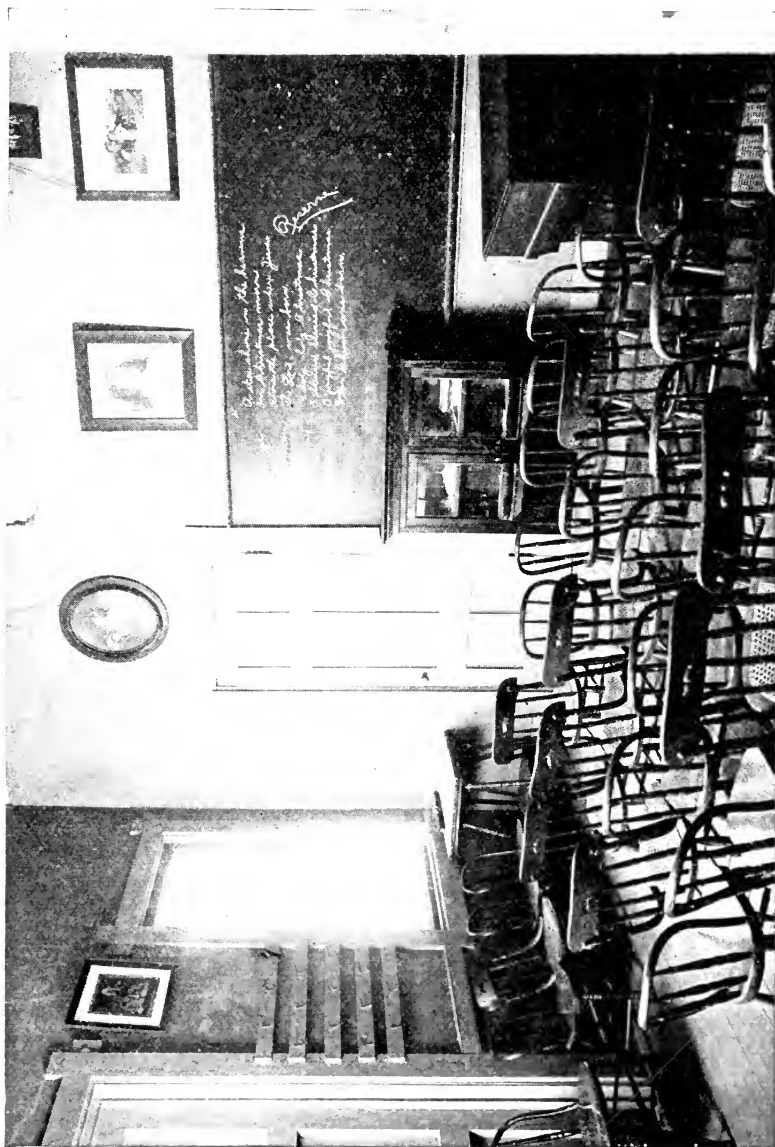
ILLUSTRATION 40. A PRIMARY CLASS ROOM, MAPLEWOOD CONGREGATIONAL CHURCH WITH INADEQUATE NATURAL AND ARTIFICIAL LIGHT. PICTURES TOO HIGH. EQUIPMENT MEAGER AND UNATTRACTIVE

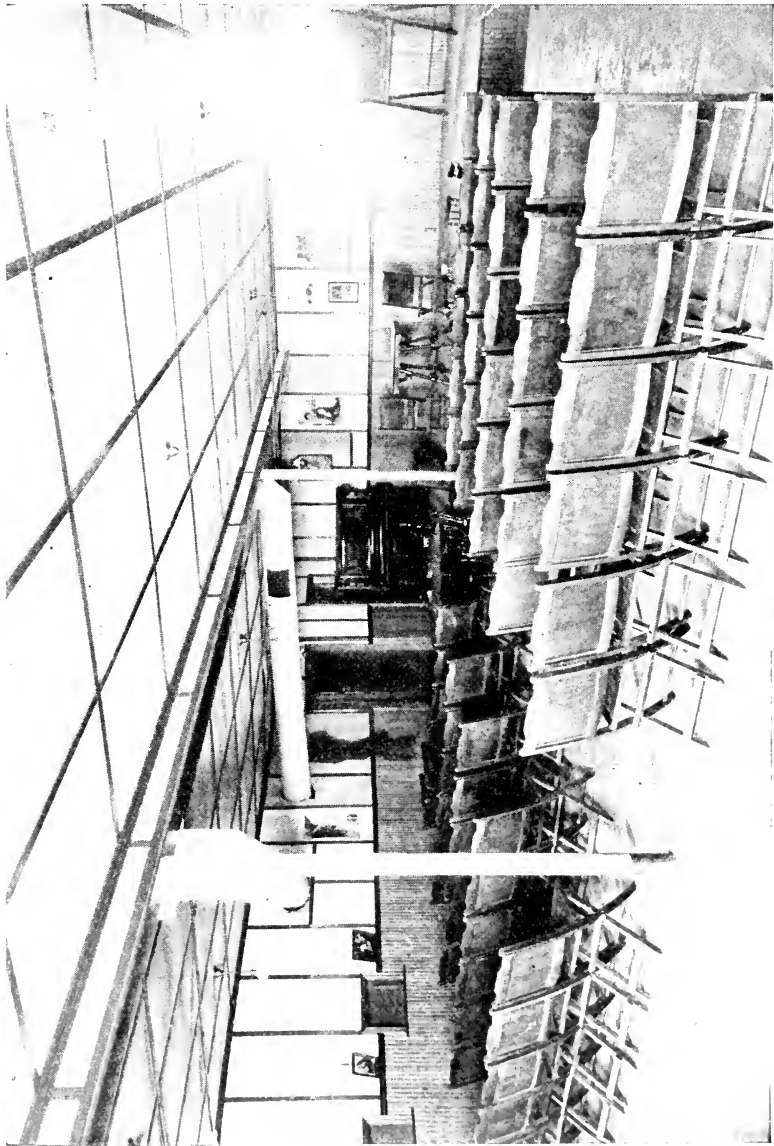
ILLUSTRATION 42. THE SUNDAY SCHOOL ROOM, LINDEN METHODIST CHURCH. COMPOSITION BOARD WALLS, CEMENT FLOOR, THE SECONDARY HEATING SCHEME AND THE POOR NATURAL LIGHTING CAUSE THIS BASEMENT ROOM TO RATE LOW

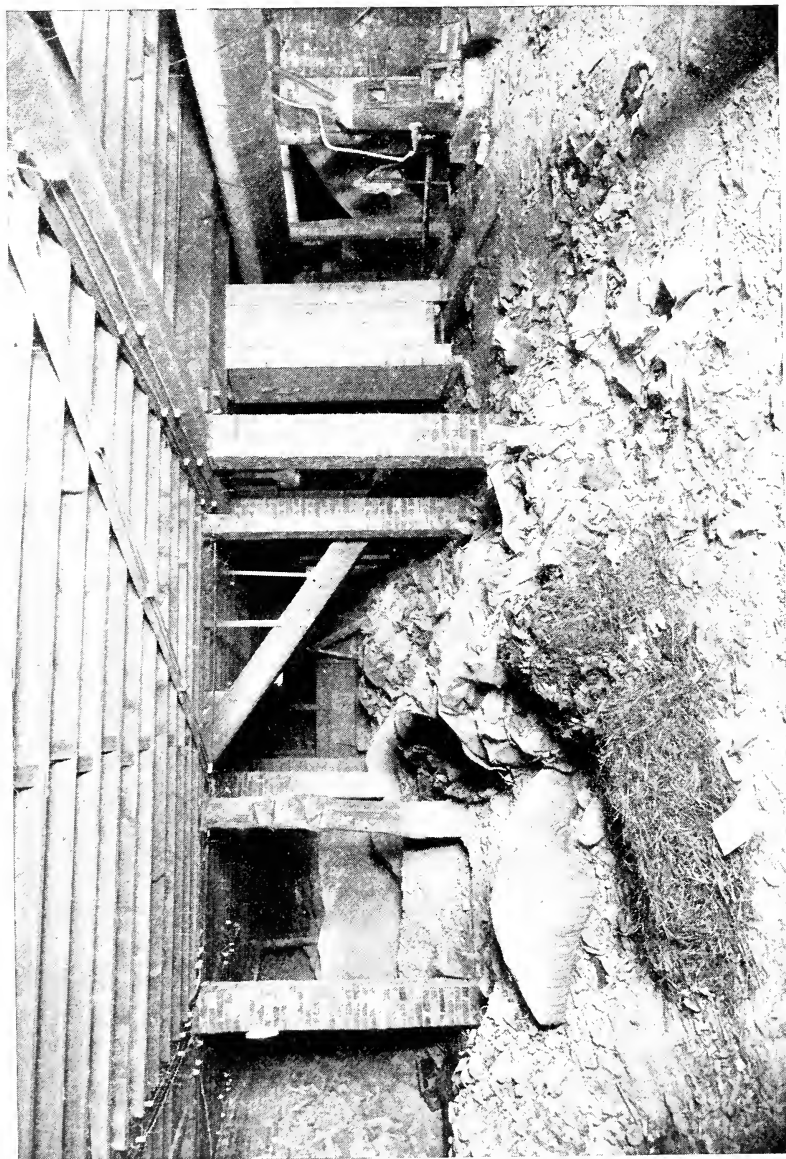
ILLUSTRATION 43. THIS BASEMENT IN THE MAPLEWOOD BAPTIST CHURCH PRESENTS MANY FIRE HAZARDS WHICH SHOULD NOT BE TOLERATED IN ANY PUBLIC BUILDING

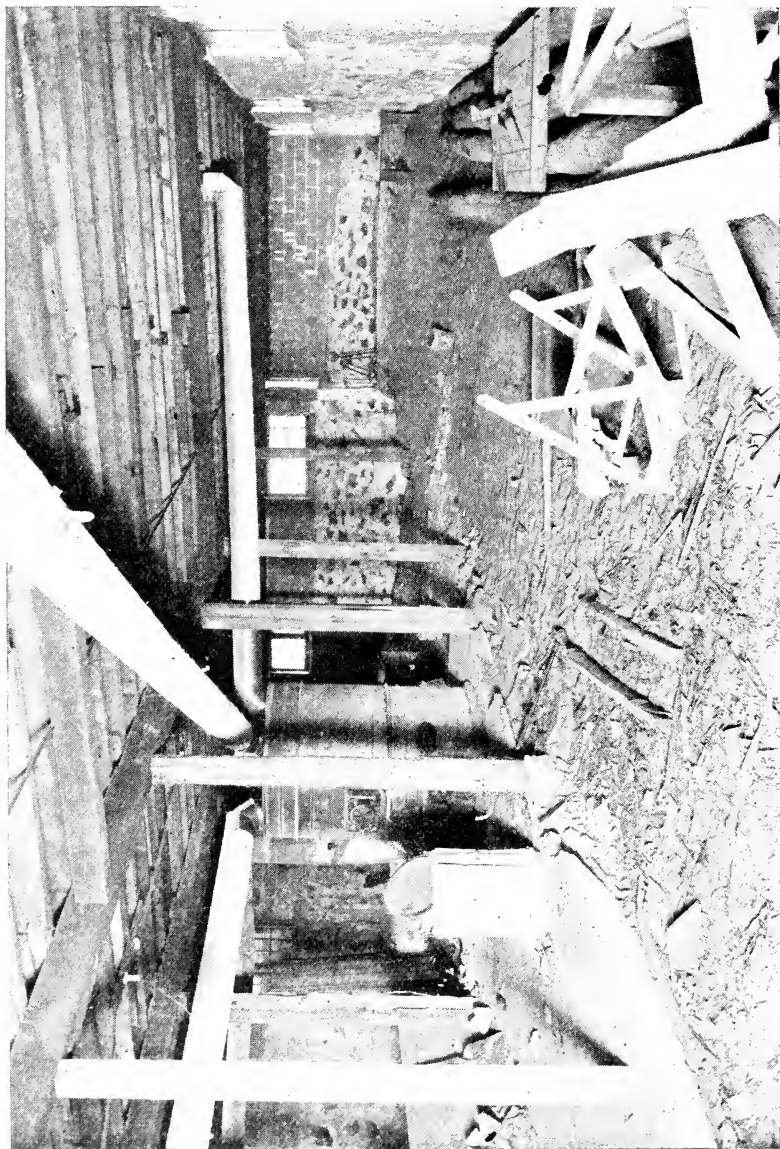
ILLUSTRATION 44. THE BASEMENT IN ST. LUKE'S EPISCOPAL CHURCH, THE LIGHTING AND ARRANGEMENT OF WHICH SHOULD HAVE BEEN PLANNED FOR PLAY AND RECREATION FOR CHILDREN

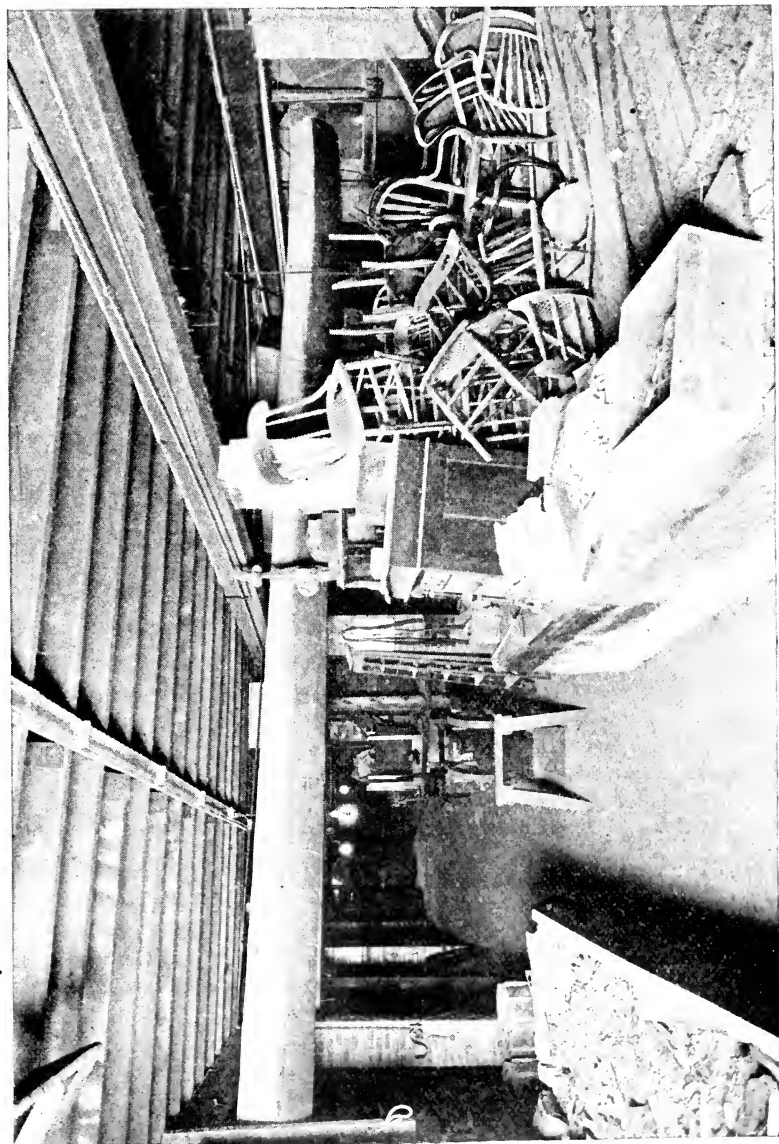
ILLUSTRATION 45. THE BASEMENT OF THE FIRST CONGREGATIONAL CHURCH. NOTE THE DEFECTIVE WIRING, JOINTS UNPROTECTED FROM THE DUCTS AND HEATERS, ONE OF THE FIVE HEATERS LOCATED IN THIS CONGESTED BASEMENT IS SEEN AT THE RIGHT

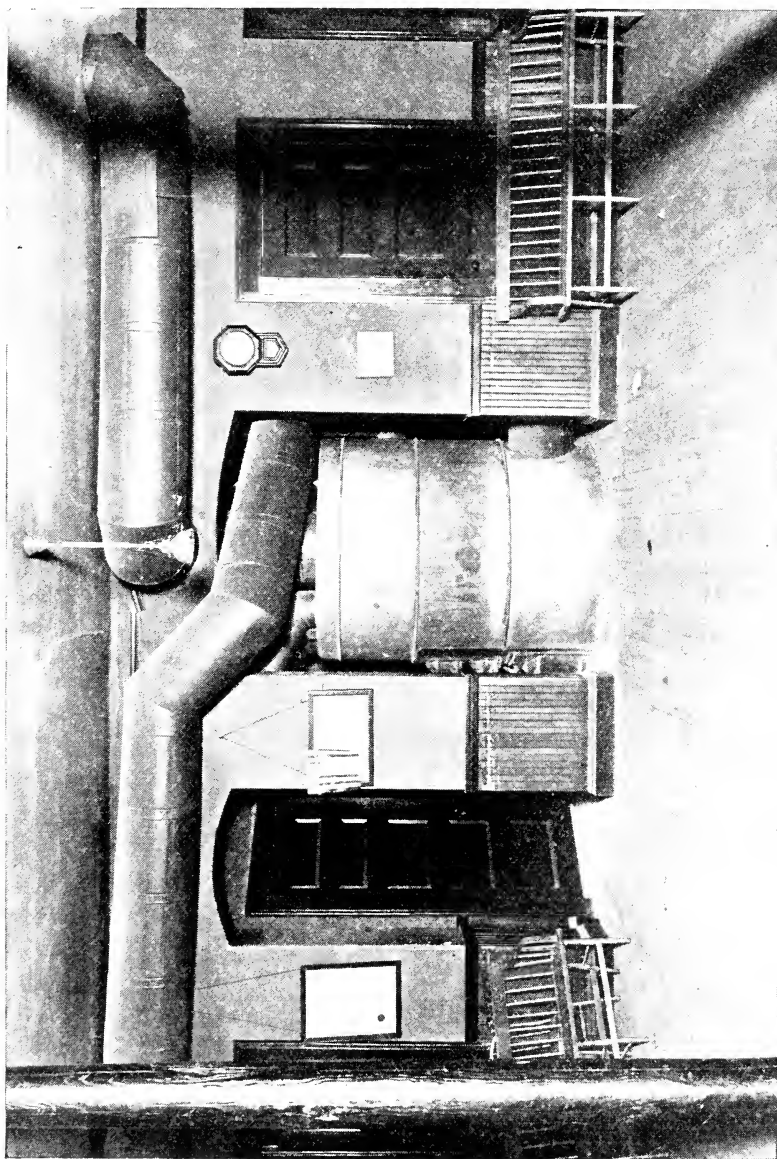
ILLUSTRATION 50. ONE OF THE UNPROTECTED FURNACES OF THE MYSTIC SIDE CONGREGATIONAL CHURCH FURNISHING A CONSTANT POSSIBILITY OF FIRE DANGER. THIS CONSTRUCTION SHOULD NEVER HAVE BEEN PERMITTED BY LAW

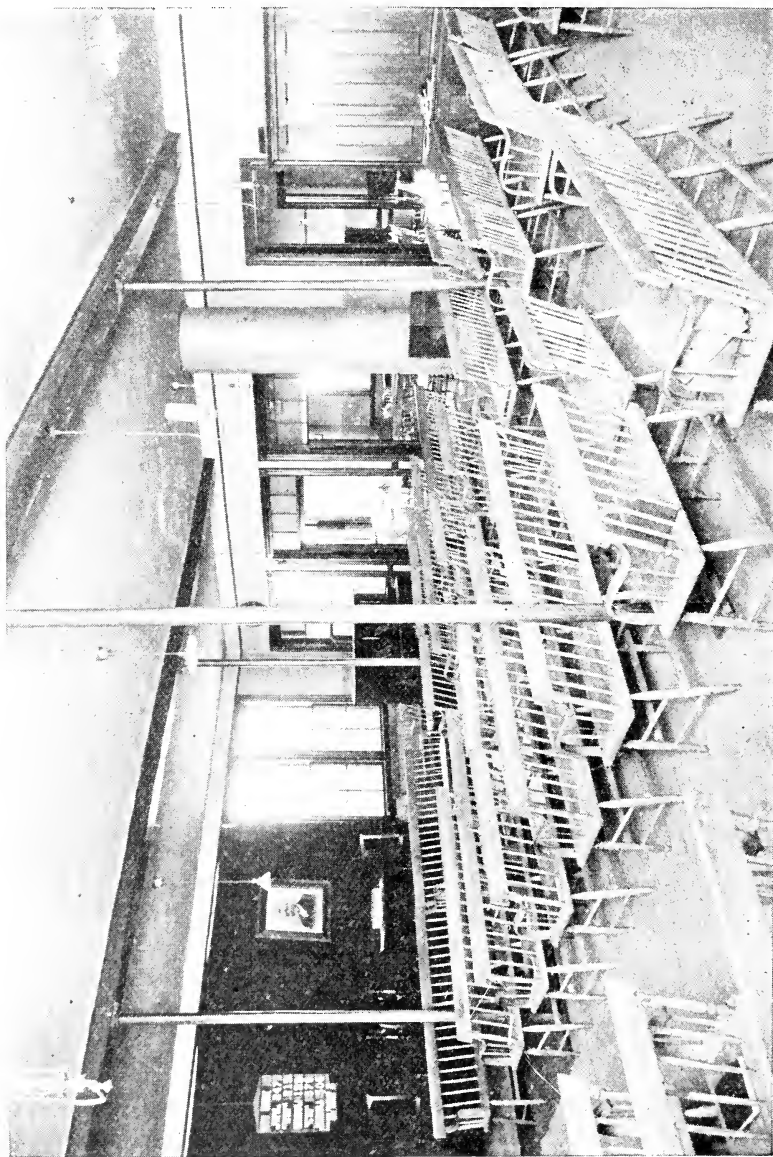
ILLUSTRATION 51. SHOWING THE SUNDAY SCHOOL ROOMS OF THE MAPLEWOOD METHODIST CHURCH.
NOTE THE FLUE METHOD OF HEATING AT THE RIGHT CENTRE; THE INADEQUATE ARTIFICIAL
LIGHTING AND THE UNDESIRABLE FURNITURE

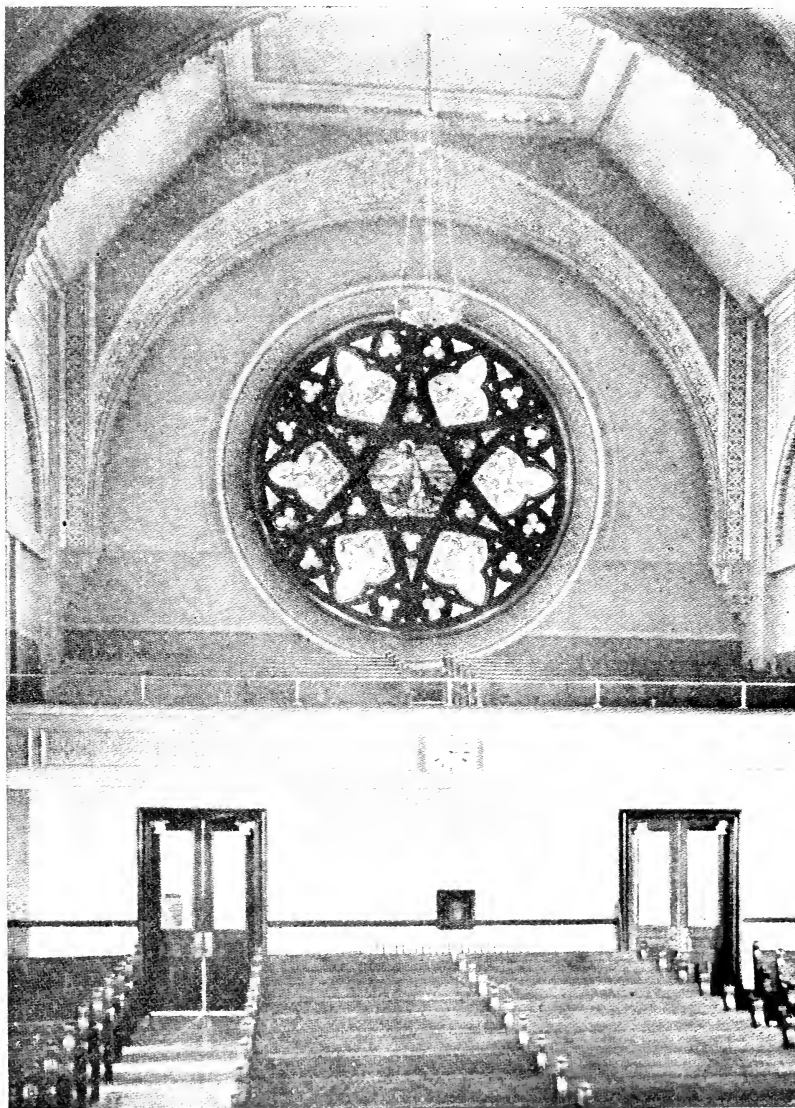
ILLUSTRATION 53. AN ATTRACTIVE INTERIOR OF THE CENTRE METHODIST CHURCH. THIS SHOWS THE SECOND STORY AUDITORIUM FLOOR WITH PART OF ITS THIRD STORY BALCONY, WHERE ABOUT 1000 PEOPLE MAY BE SEATED. AUDITORIUMS, UNLESS IN STRICTLY FIREPROOF BUILDINGS, SHOULD BE AT GROUND LEVEL.

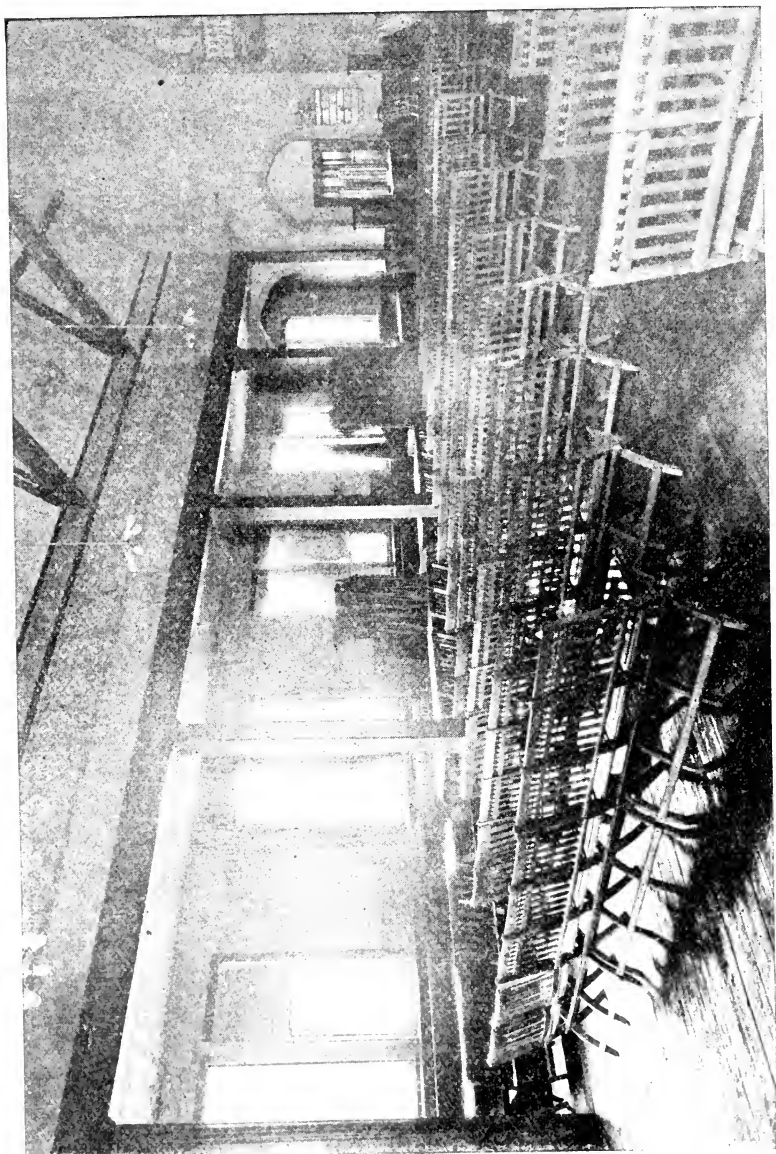
ILLUSTRATION 56. TEMPORARY SUNDAY SCHOOL ASSEMBLY ROOM OF ST. PAUL'S EPISCOPAL CHURCH. CURTAINS ON WIRES PROVIDE CLASSROOMS ABOUT EDGE OF ROOM. BAD CONDITION OF FLOOR, POOR KIND OF ARTIFICIAL LIGHTING AND INADEQUATE NATURAL LIGHTING SHOWN

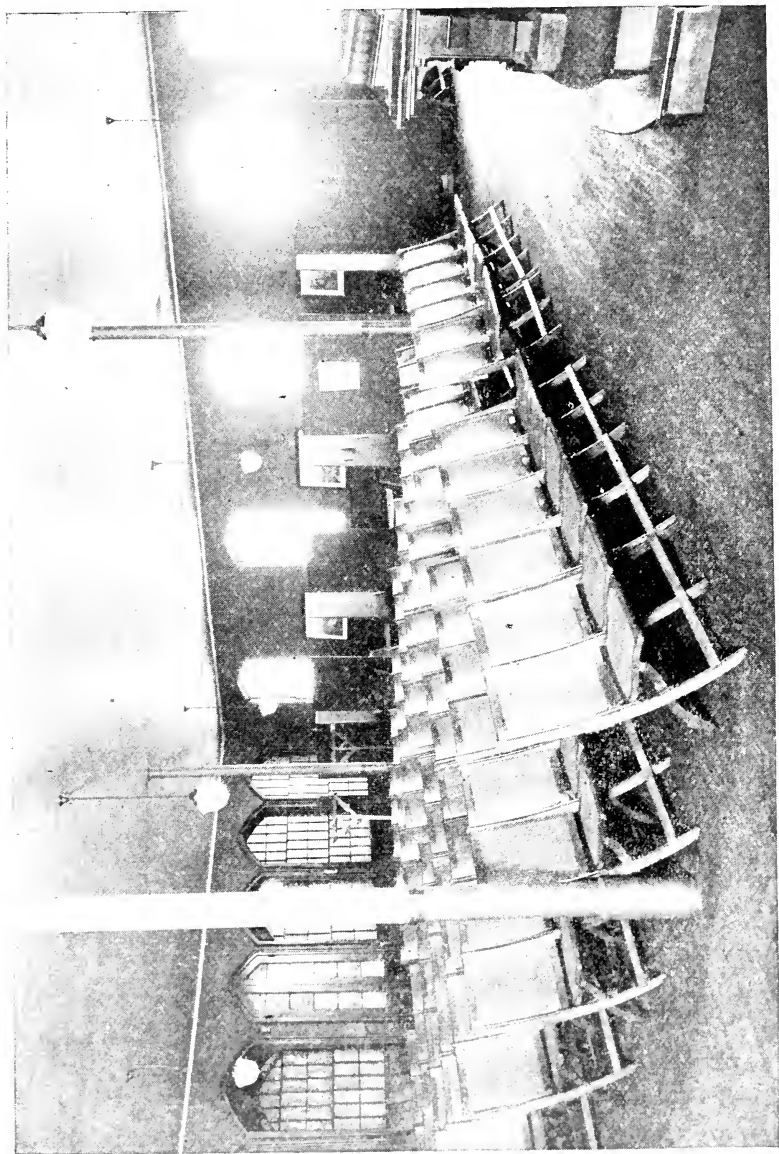
ILLUSTRATION 57. SUNDAY SCHOOL ASSEMBLY ROOM, FIRST CONGREGATIONAL CHURCH SHOWING THE MAKE-SHIFT SCREENED CLASS ROOMS AT SIDE OF ROOM NOTE THE SPLENDID TYPE OF ELECTRIC FIXTURES USED

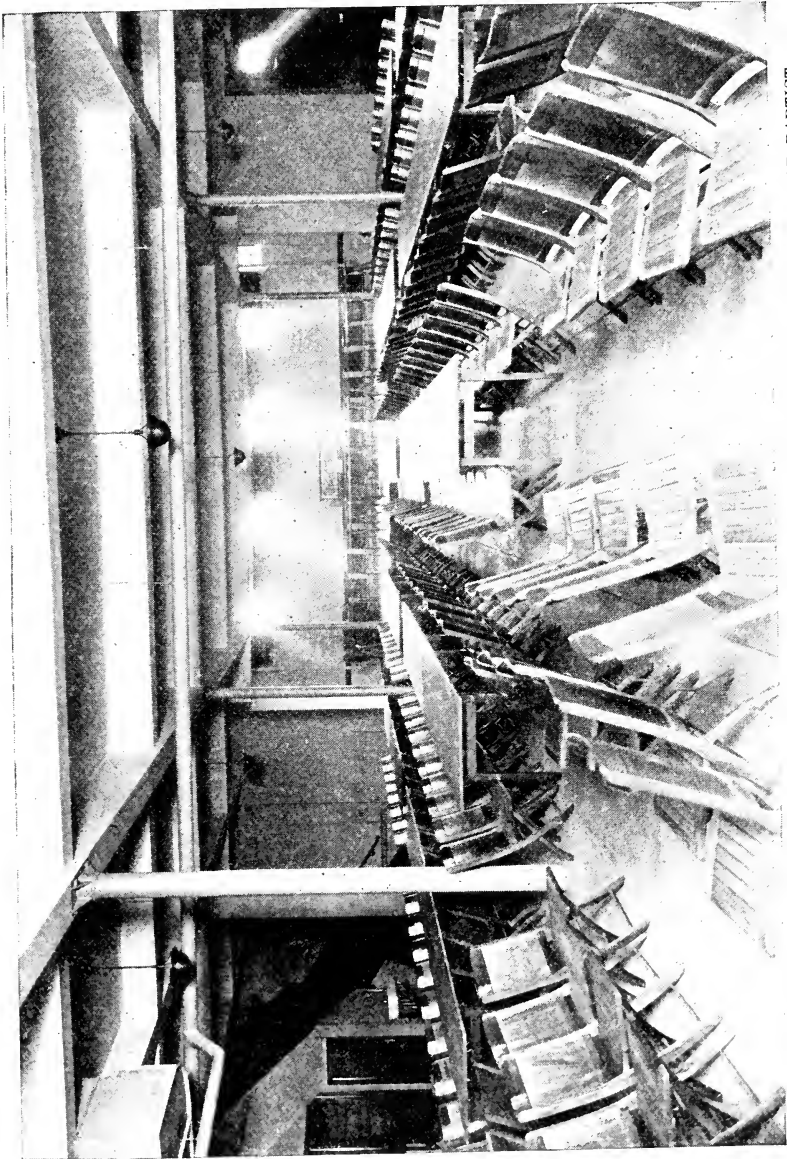
ILLUSTRATION 58. THE WELL-APPOINTED BANQUET ROOM IN THE BASEMENT OF THE FIRST BAPTIST CHURCH. SPLENDID INDIRECT ARTIFICIAL LIGHTING BUT INADEQUATE NATURAL LIGHTING

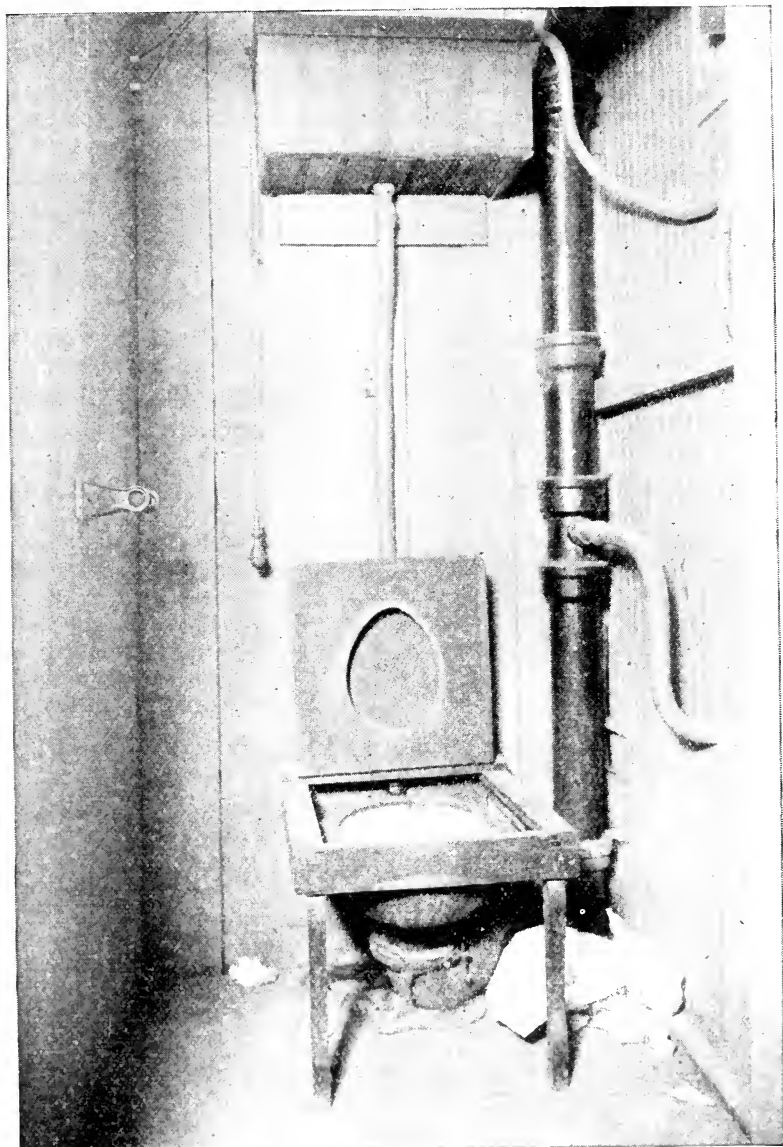
ILLUSTRATION 60. THE EXTREMELY UNSANITARY TOILET PROVISIONS OF THE ST. LUKE'S EPISCOPAL CHURCH

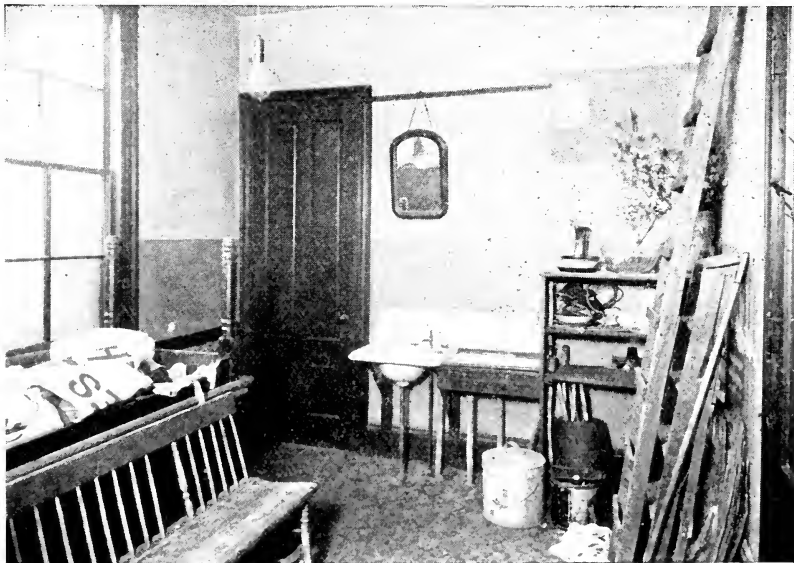
ILLUSTRATION 61. UNATTRACTIVE, POORLY-EQUIPPED KITCHEN OF THE MAPLEWOOD METHODIST CHURCH

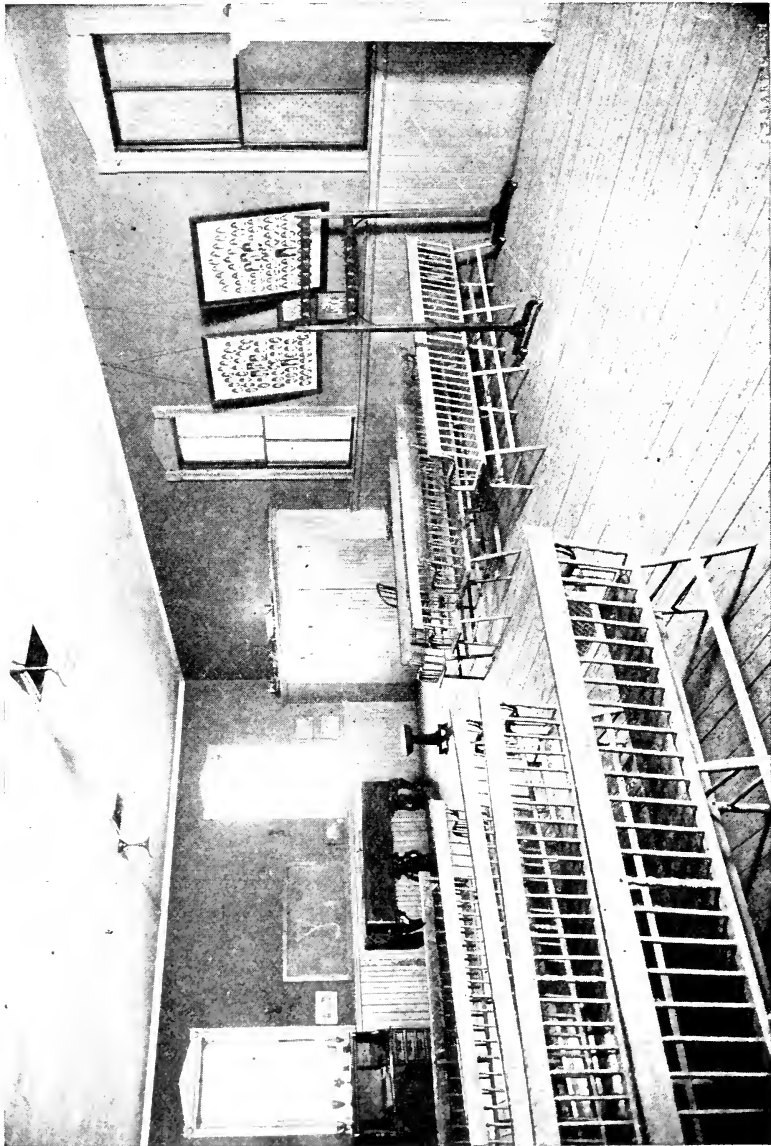
ILLUSTRATION 66. CHOIR ROOM IN THE TEMPORARY PART OF ST. PAUL'S EPISCOPAL CHURCH. ROOM IS LARGE ENOUGH BUT EQUIPMENT IS VERY POOR, AND NO ATTEMPT TO MAKE ROOM ATTRACTIVE

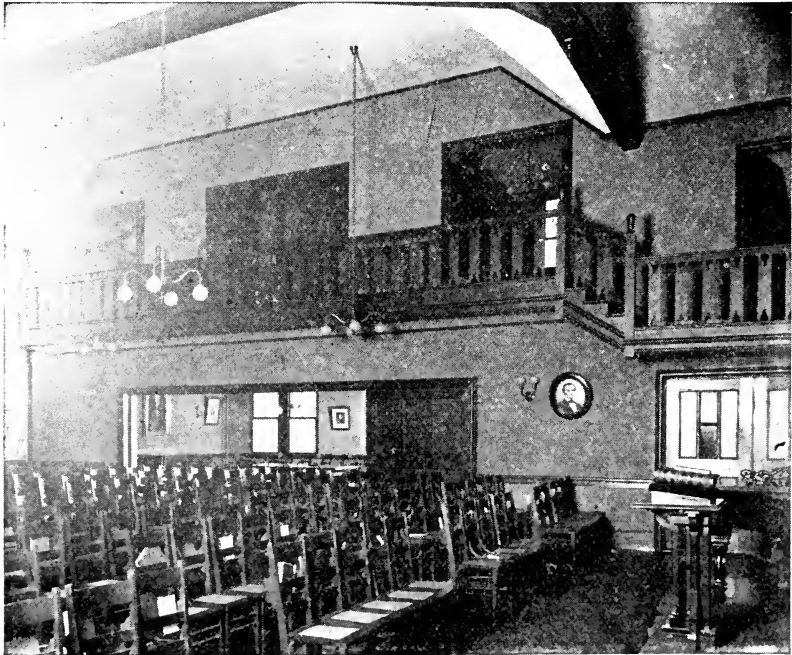
ILLUSTRATION 69. SUNDAY SCHOOL ASSEMBLY ROOM OF THE FIRST PARISH IN MALDEN, UNIVERSALIST. A WELL FURNISHED, IMPROPERLY LIGHTED ROOM, SHOWING BALCONY CONNECTION TO INADEQUATE CLASS ROOMS

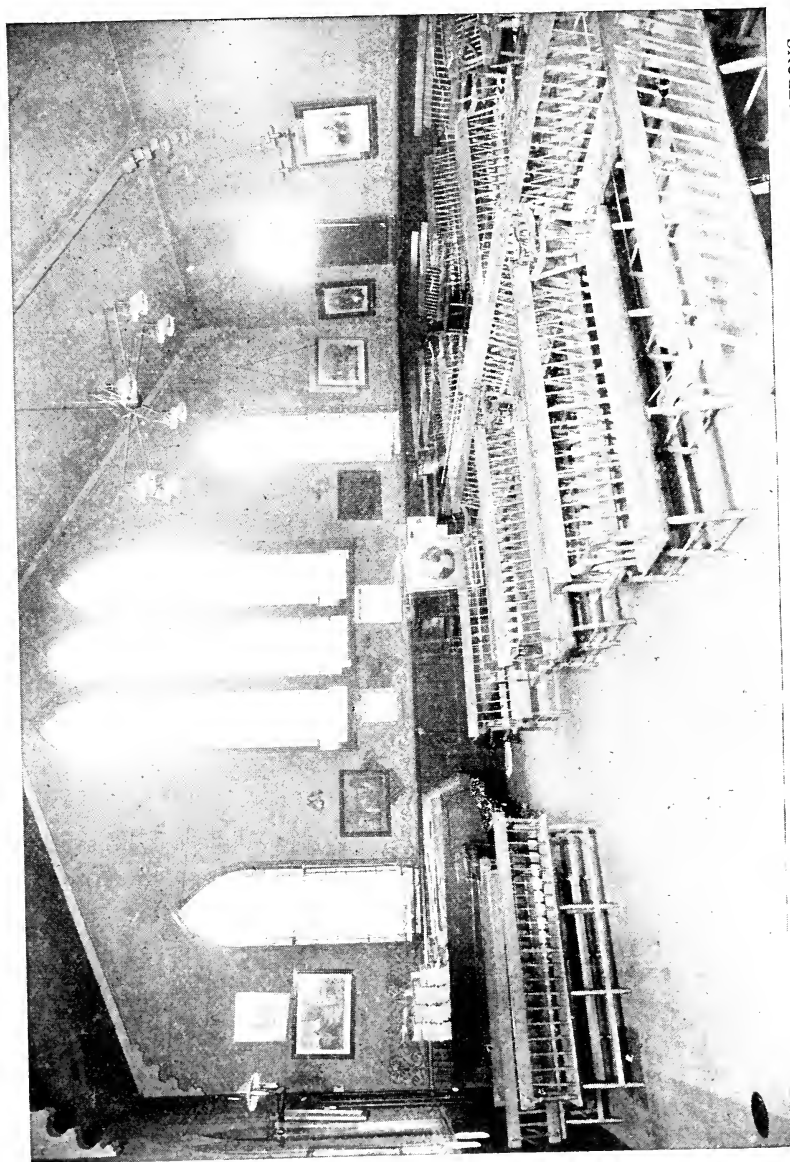
ILLUSTRATION 71. SUNDAY SCHOOL ASSEMBLY ROOM OF MAPLEWOOD BAPTIST CHURCH. NOTE STRONG LIGHT TO BE FACED, POOR ARTIFICIAL LIGHTING, AND BENCHES ARRANGED FOR SEATING A DOZEN OR MORE CLASSES IN THE SAME ROOM

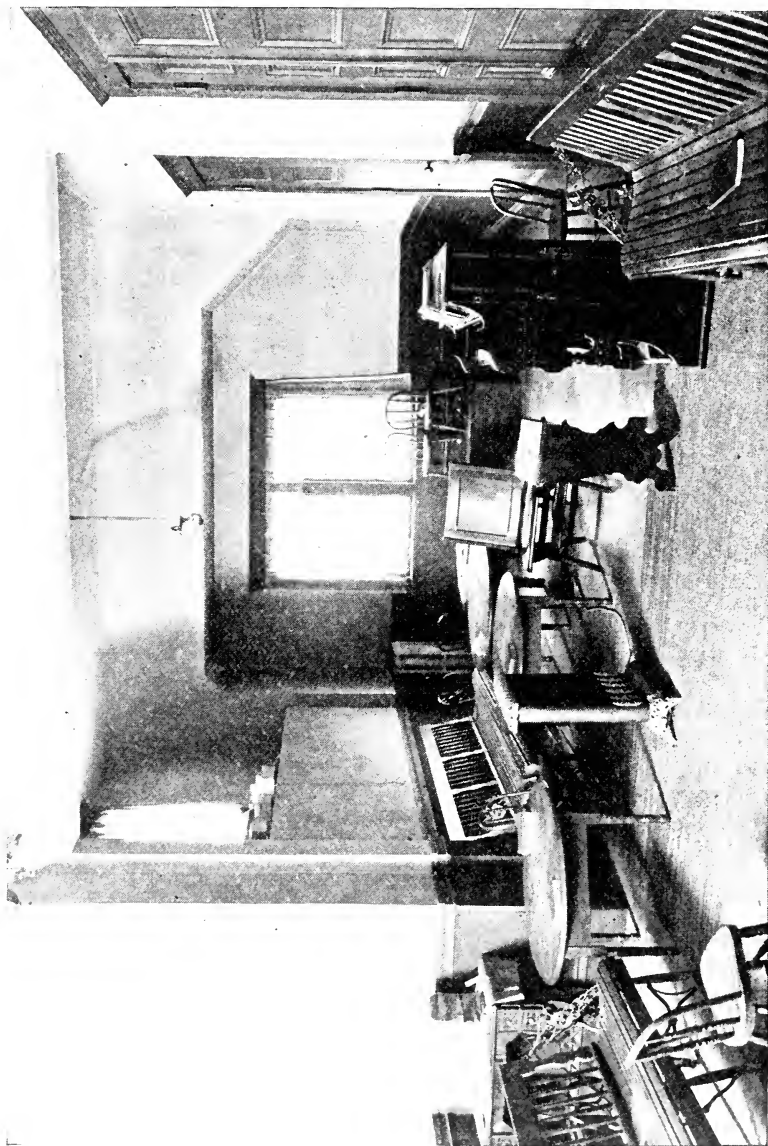
ILLUSTRATION 75. PRIMARY CLASS ROOM, FALCONER METHODIST CHURCH. IRREGULAR AND INADEQUATE FURNITURE, INCONVENIENT ARRANGEMENT, GAS HEATER, AND GAS LAMPS

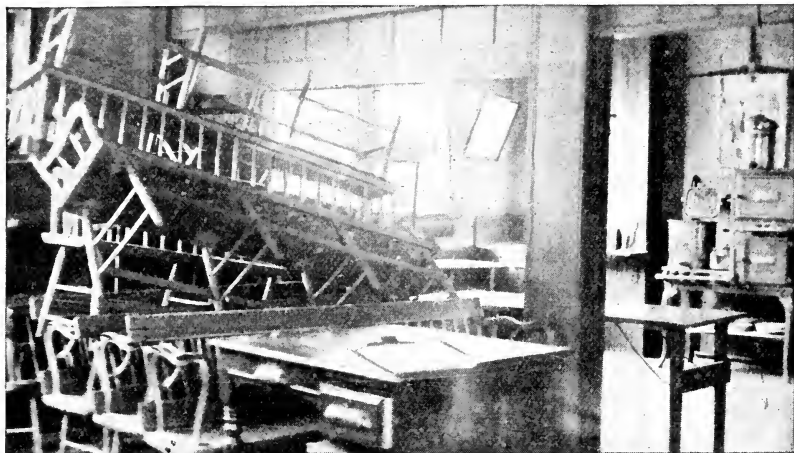
ILLUSTRATION 79. KITCHEN AND CLASS ROOM OF MAPLEWOOD BAPTIST CHURCH USED AS A STORE ROOM BECAUSE OF FAILURE TO PROVIDE SUCH SPACE IN ORIGINAL PLANS

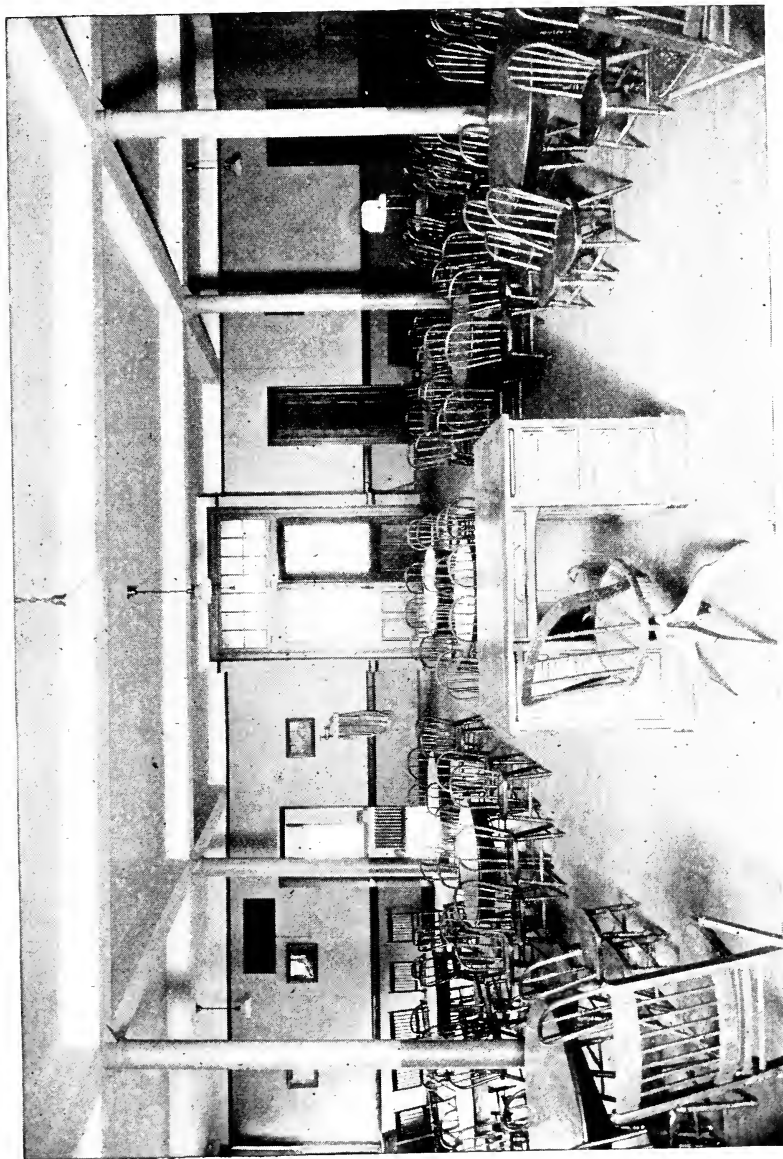
ILLUSTRATION 80. CLASS ROOM, FIRST BAPTIST CHURCH. WELL EQUIPPED, ATTRACTIVE CLASS ROOM, BUT WITH INADEQUATE NATURAL LIGHT DUE TO BLANK WALL ON ONE SIDE OF BUILDING

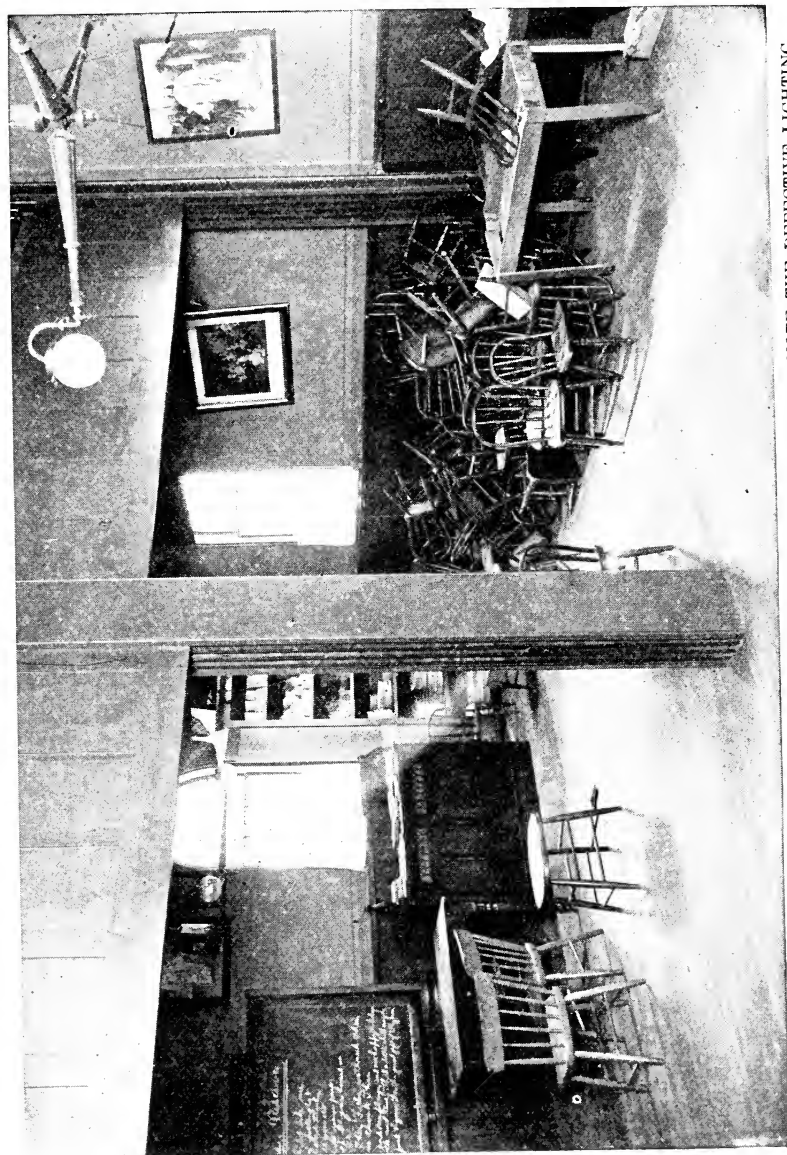
ILLUSTRATION 81. CLASS ROOMS IN THE MAPLEWOOD BAPTIST CHURCH. NOTE THE DEFECTIVE LIGHTING, THE POOR EQUIPMENT AND THE MAKESHIFT SAND BOX. TEACHING BECOMES DIFFICULT UNDER THESE CONDITIONS
